Manhole Inspection Summary

Manhole # S17S__012MH

Insp Date: **5/5/09 9:29 AM**

Location Address: **1500 CARROLL PARK**

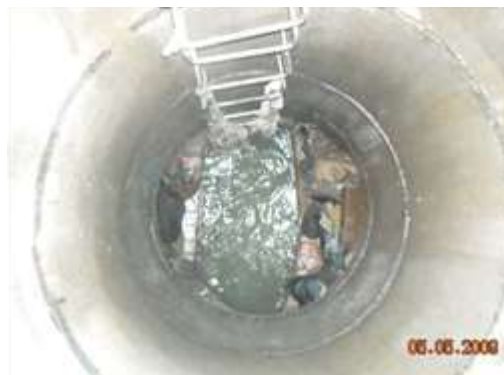
Top View

Comments **WHEN APPROACHING GWYNNS FALLS TRAIL FROM WASHINGTON BLVD: FOLLOW PAVED TRAIL NORTH @ FORK TAKE RIGHT HAND GRAVEL PATH, BEFORE THE CART BRIDGE, PAVEMENT IS MARKED; MAN ENTRY WAS REQUIRED TO REMOVE SURCHARGE EVIDENCE FROM INFRONT OF 12 OCLOCK PIPE**
